Pennsylvania
Coastal Zone
Management Program

SHORELINE EROSION
AND FLOODING

ERIE COUNTY

June 1975

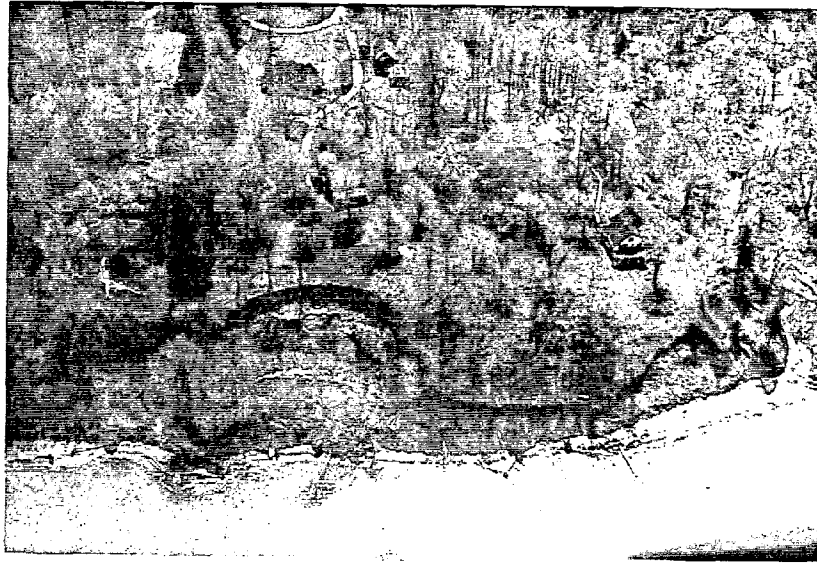
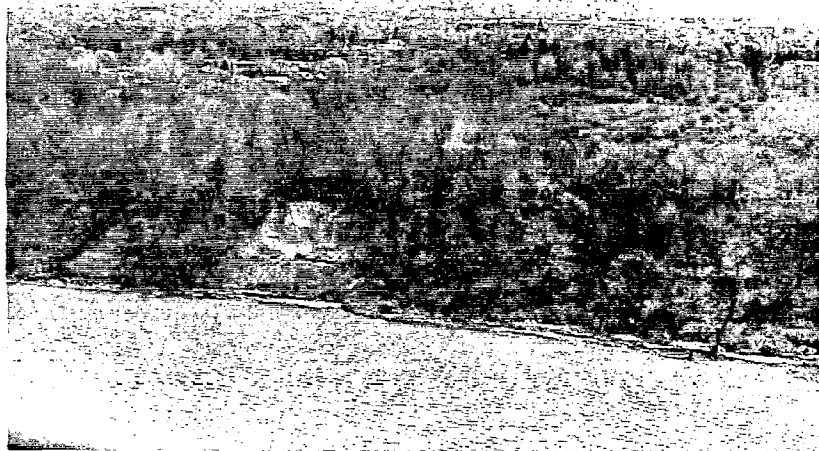
Above and below: Cirque-like features produced
by landslides in weakened materials.

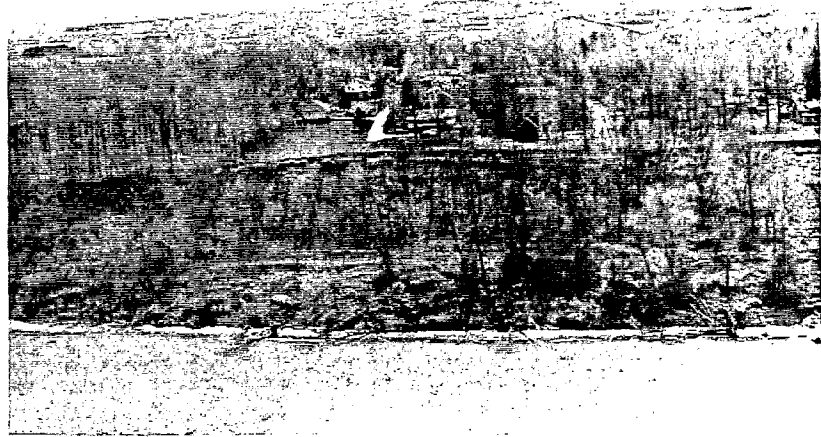
Above: An area of slumping due probably to increased infiltration of ground water because to vegetation cover at crest

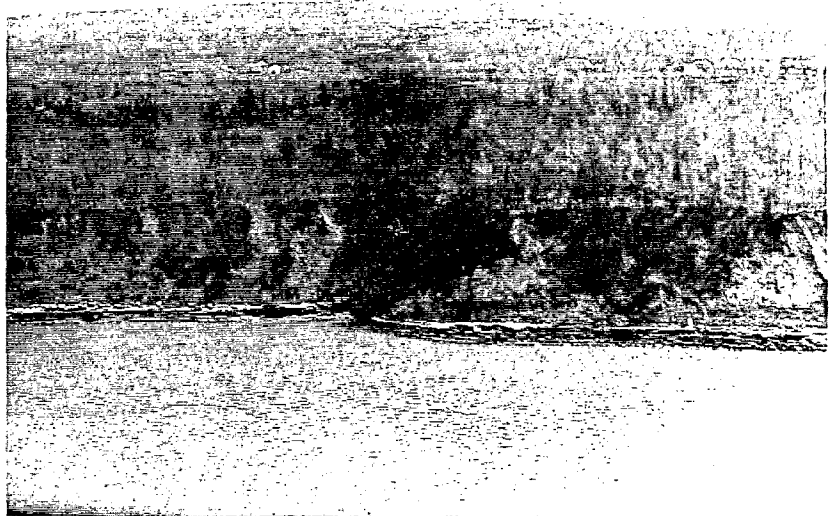
Above: Typical hummocky appearance produced by landslide activity

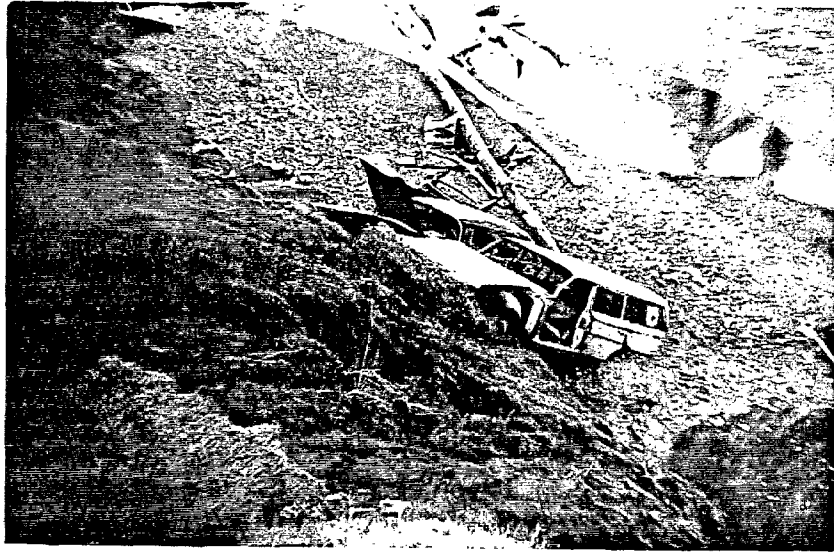
Above: Junked cars at base of bluff, Elk Creek; an attempt to retard slope failure

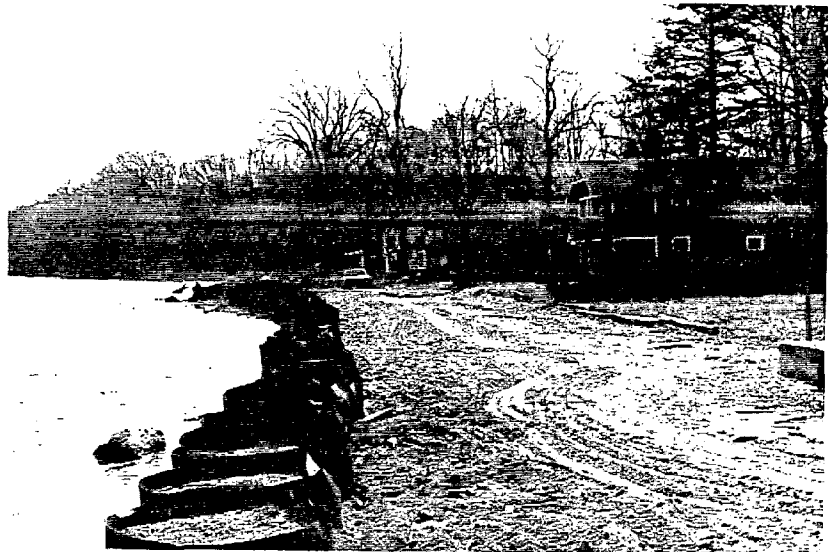
Above: Steel pipes, 8 feet long, 5 feet in diameter and filled with concrete, offer some protection to this cottage association, East County

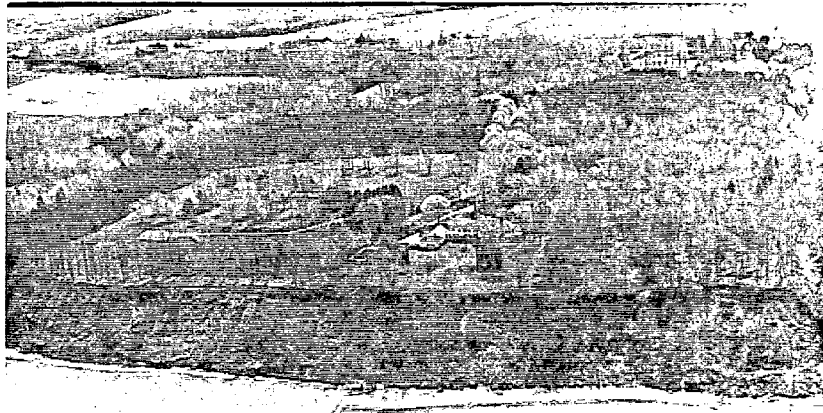
Above: Cause and effect: groin construction in center has restricted sand accumulation to the left (East) producing accelerated erosion

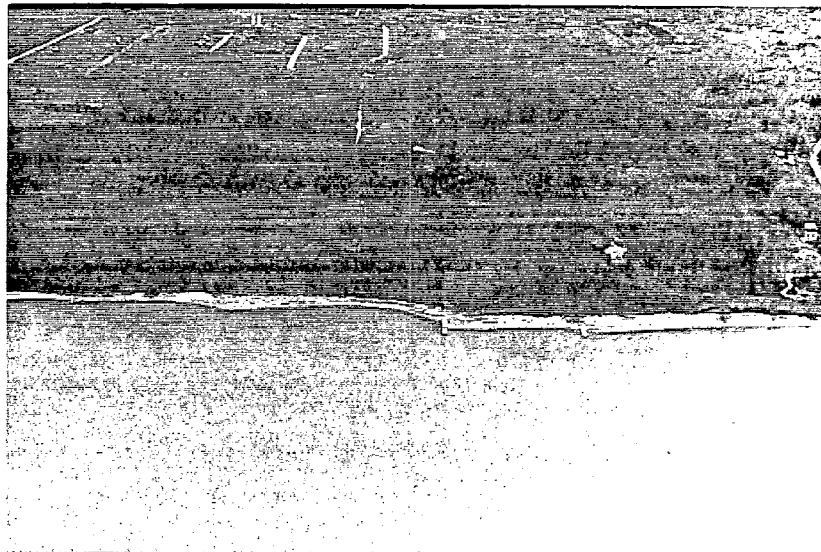
Above: Typical groin placement for beach nourishment. Despite high water, sand accumulation is significant.

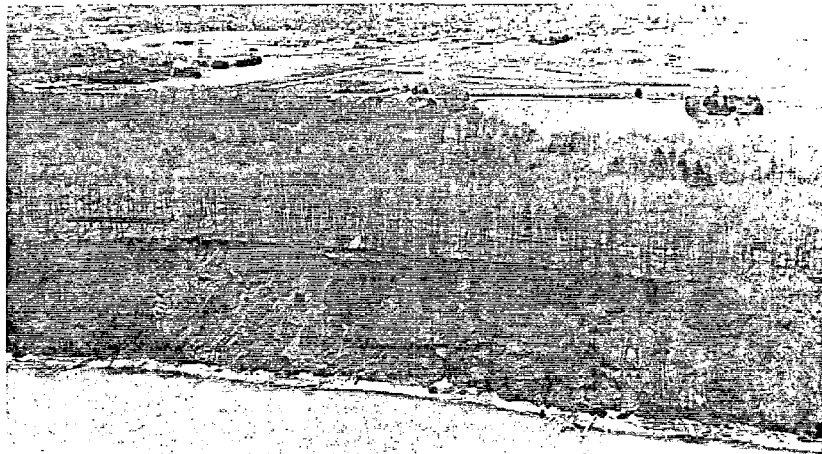
Above: Vegetation as an indication of movement - slump
block in center with trees upright

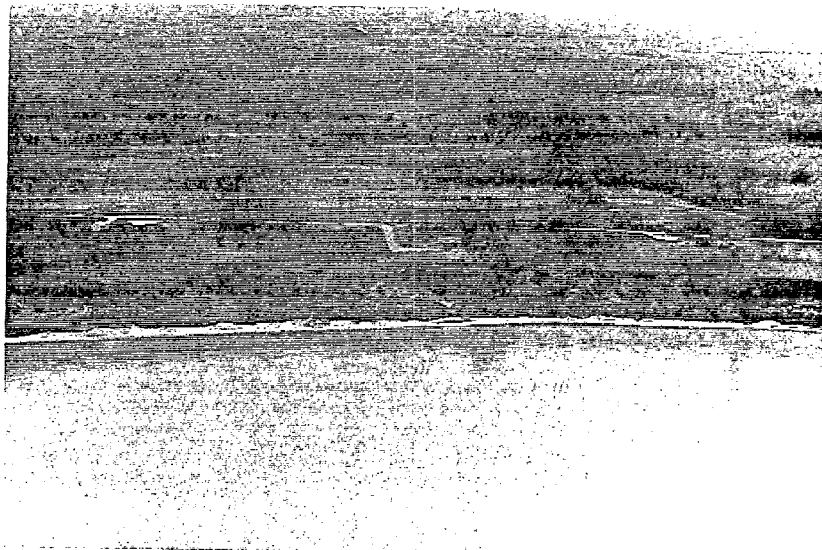
Above: Area of rapid recession: land cover beyond bluff
is a contributory cause of recession

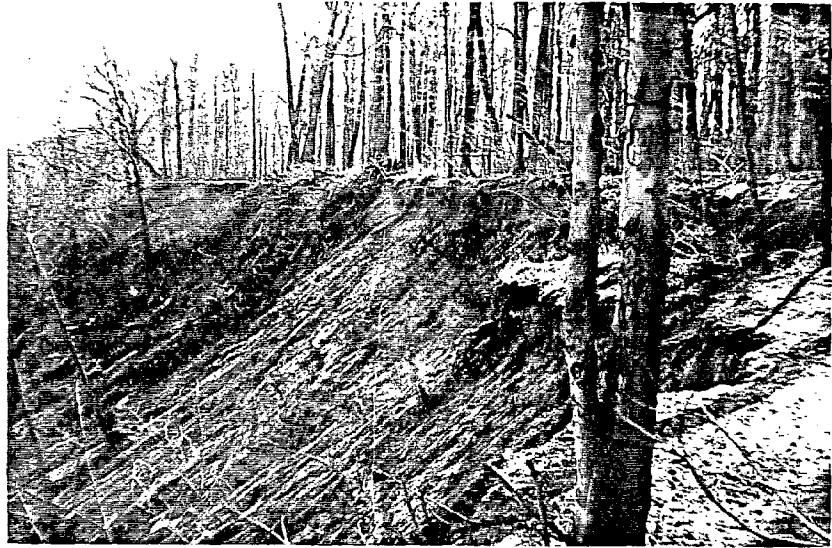
Above and below: Vegetative disruption on bluff as
indication of slope activity

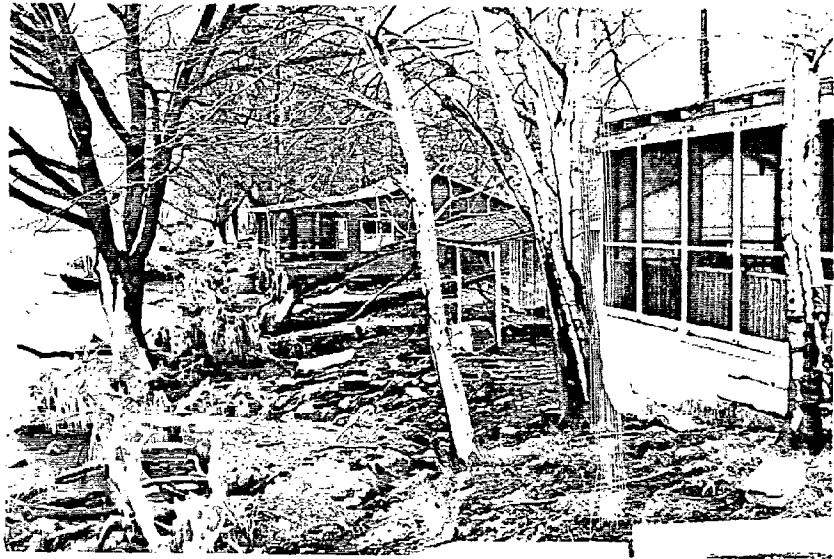
SHORE ZONE DESCRIPTION: Vertical bluff at Holliday Road subject to rapid recession; project team recorded 4 ft. recession from February to May, 1975. Practically all trees in beach zone have been washed away. Cottages have suffered flooding and damage from waves, ice, and toppled trees. At Crooked Creek, groins built since 1973 have built up beach and protected cottages.

Above: Damage to beach and structures at Holliday Shores

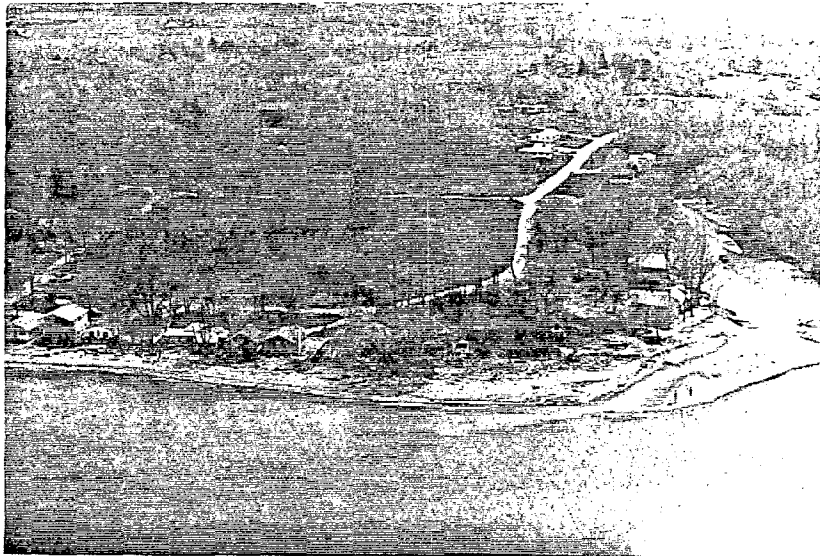
Above: Sunset Beach, Sixteen Mile Creek, North East Township; showing flood potential behind bay mouth bar

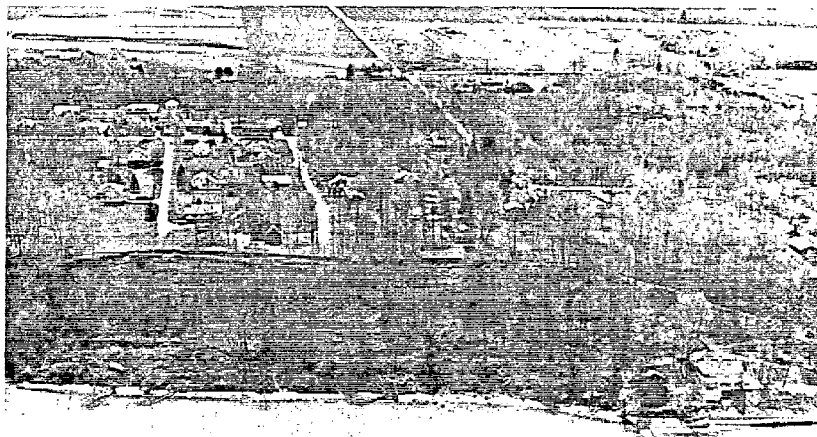
Above: Vicinity of Culbertson Road, Girard Township;
showing recent slumping at crest of bluff

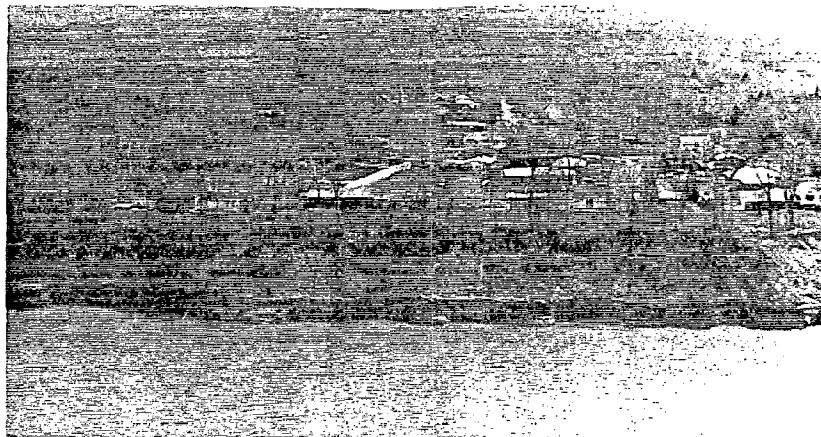
Above: Cambridge Road - Northview Drive, west of Six Mile Creek, Harborcreek Township; showing scalloping of bedrock

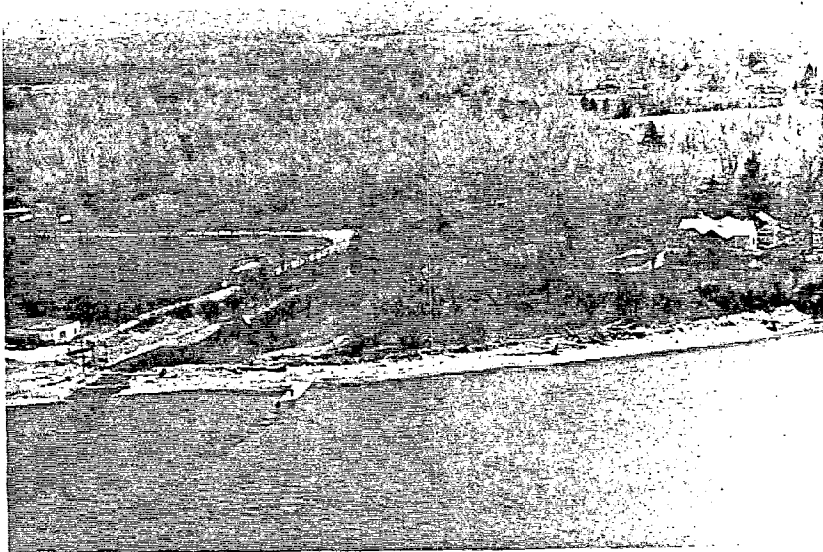
Above: Six Mile Creek, Harborcreek Township; showing formation of bay mouth bar

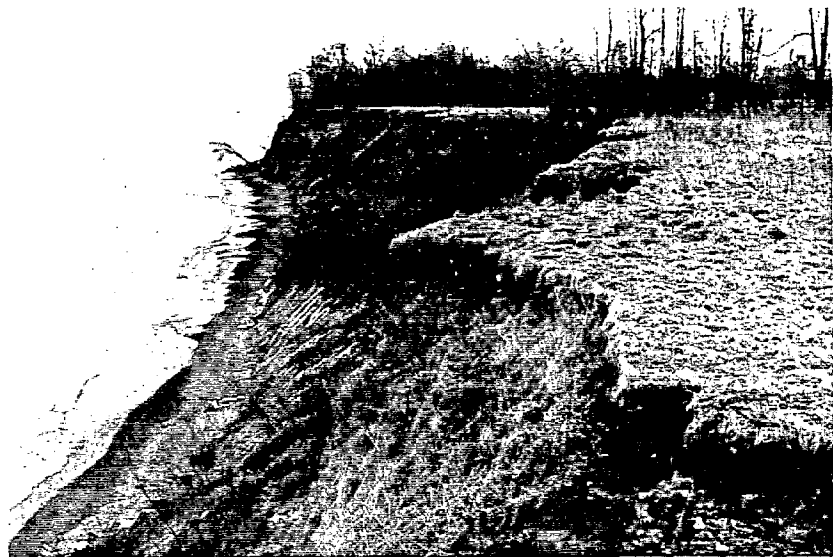
Above and below: Slopes of various slope produced in
relation to recession activity in Springfield
Township

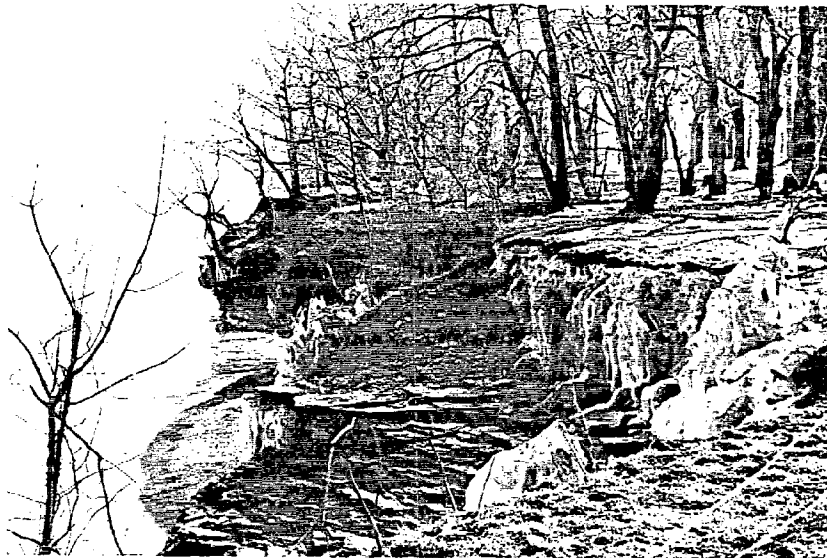
Above and below: Shelving over bedrock produced differential erosion of bluff - Harborcreek Township
